Manhole Inspection Summary

Manhole # S63A__007MH

Insp Date: **5/22/08 2:15 PM**

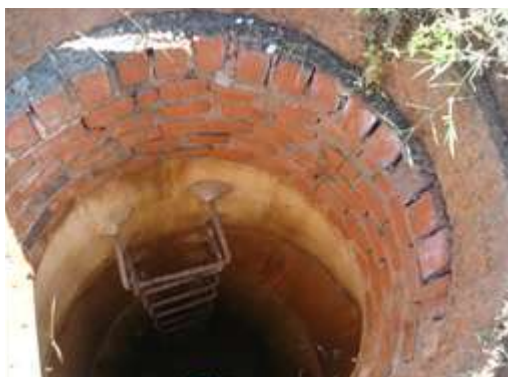
Defect 1

Condition: ☐ Sound ☐ Cracked ☐ Root Intrusion ☒ **Loose Brick** ☐ Deteriorated

loose brick

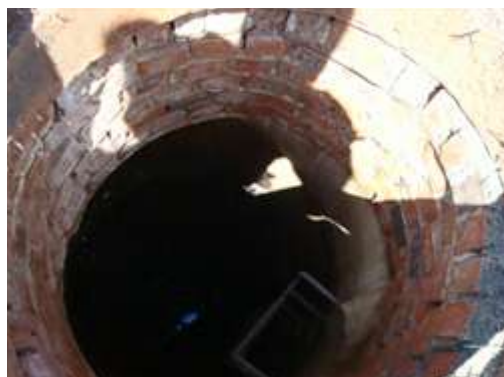
Defect 2

Infiltration: ☐ None ☒ **Joint** ☐ Cracks ☒ **Mortar** ☐ Roots ☐ Wall

infiltration

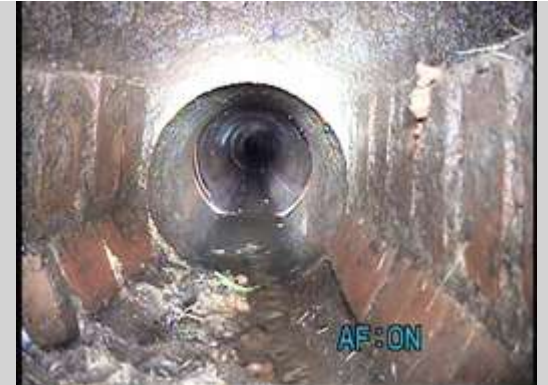
12 O'Clock Outflow

Pipe Height: **8.4** (in.) Rod and Bar (Angled)
Pipe Material: **Clay** ☐ Pipe Lined
Invert Depth: **18.00** (ft.) Flow Characteristics: **Fast**
Deposits: ☒ None ☐ Mud ☐ Sludge ☐ Debris ☐ Grease
Silt Depth: (in.) Deposits Extent:
Infiltration: **None** Pipe Seal Cond: **Sound**

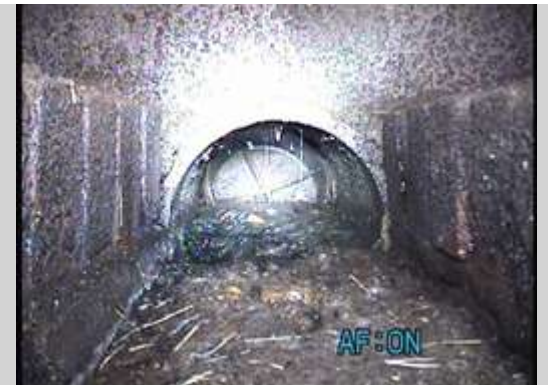
6 O'Clock Inflow

Pipe Height: **8.4** (in.) Rod and Bar (Angled)
Pipe Material: **Clay** ☐ Pipe Lined
Invert Depth: **18.10** (ft.) Flow Characteristics: **None**
Deposits: ☒ None ☐ Mud ☐ Sludge ☐ Debris ☐ Grease
Silt Depth: (in.) Deposits Extent:
Infiltration: **None** Pipe Seal Cond: **Sound**

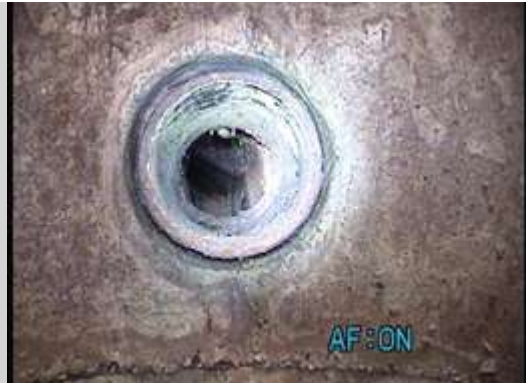
9 O'Clock Inflow

Pipe Height: **8.4** (in.) Rod and Bar (Angled)

Infiltration: **None** Pipe Seal Cond: **Sound**

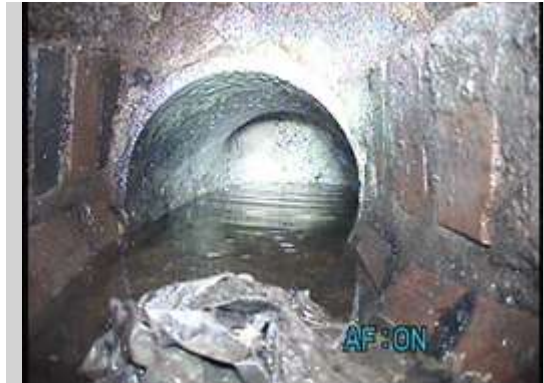
Drop In @ 9 O'Clock

Drop: **Inside**

Drop Condition: **Open**
